## **Most Improved Award**

**German Space Education Institute  
Moonbuggy Team 2008**

## **1. Damage – analyses - causation – adjustment**

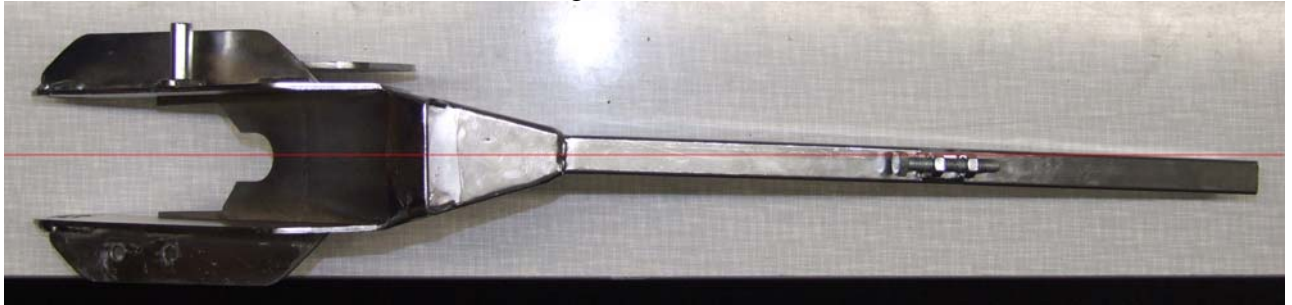
#### 1. pillar for pedals

Damage: strong deflection of the box profile to the right

Deviation: 42 mm (measured) on a lever length of 410 mm

Possible Cause: tensile forces due to the leverage effect of the drive chain, additional pressure burden of leg strength

Remedial proposal: Raise the forces encountered by simulation (Materials Testing), calculating an appropriate cross-section / profile

Fixes grind slots in twisted appointment

Holm-to measure precisely bent

Slot-welded (TIG)

- Strive to strengthen welded on

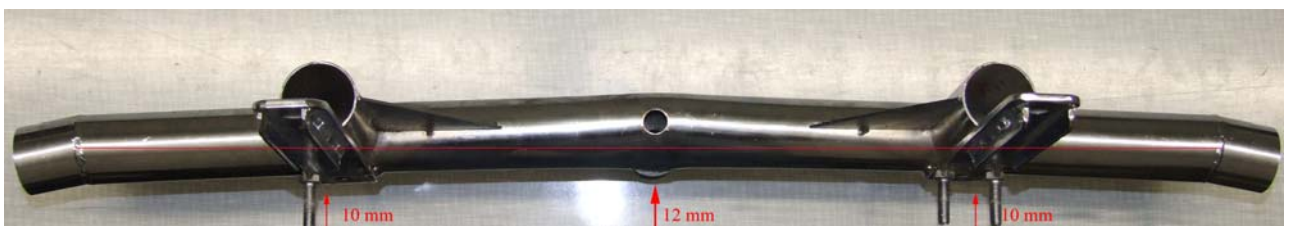
#### 2. Rear axle

Damage: complex deformation:

1st Three squeezing in the transverse axis

2nd Twisting the frame approach

3rd the flaring of hole the chassis tilting mechanism

4th cancel a seat fastening bolt

Deviations: 1a. The middle of axle has been set at 12 mm

1b / C. Seat cushions have been set at 10 mm

2nd 41 mm to a length of 100 mm below ( $10^\circ$ )

3rd 1.8 mm in the direction of travel

Possible causes: 1a-c. Too high dynamic loads by weight of the copilots  
 2nd Leverage through the leg work of the copilots or for the poorer people  
 greater emphasis behind axis (seat)  
 3rd By driving dynamics (length of the vehicle between the axles)  
 4th Inadequate welding connection

Remedial proposal: 1-2. Collect the forces who caused these deformations, recalculation of the axis (possibly new profile or striving to strengthen)  
 3rd Installation of a hole amplification (more material)  
 4th Better control of work execution

Fix: This module has been completely re-designed and stable.  
 It now includes:  
 - spring independent suspension  
 - Leaf springs from S-Ply (glass fiber)  
 - elastically supported triangular wings

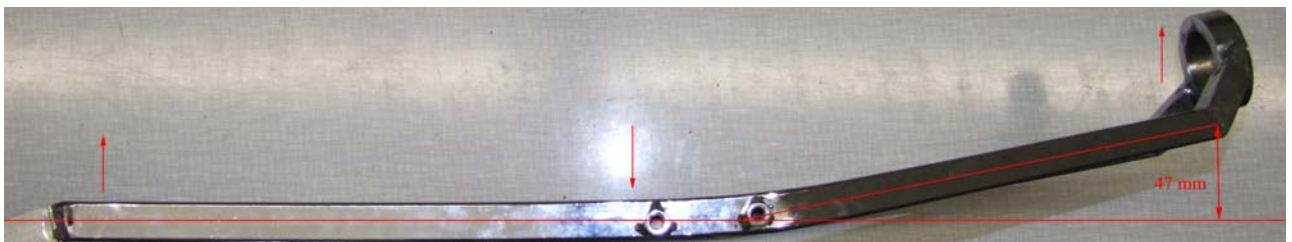
### 3. Rear support frame

Damage: strong deflection to the top  
 Deviation: 47 mm to 300 mm length

Possible causes: lack of seat suspension and rear axle, too weak component designed to vehicle dynamics, seat position copilot's footwork

Fix proposal: Structural review, possibly from plate out composite finished with honeycomb

Fix: This module was removed. There are aluminum rails on the rear frames.

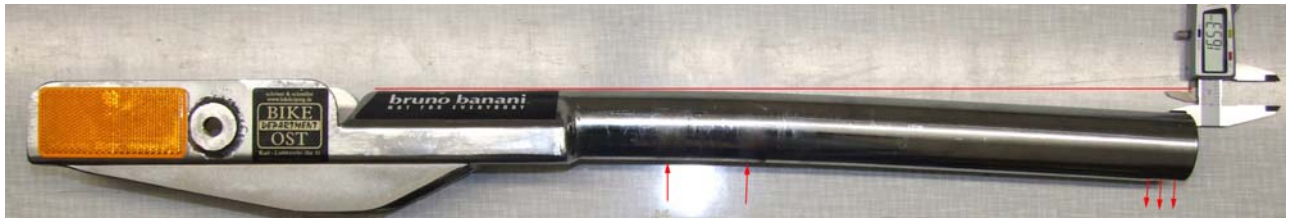
#### 4. Main Frame 2

Damage: bending piece of pipe down

Deviation: 16.5 mm to 400 mm

Possible causes: Follow appearances from the burden of the support frame (leg work of the copilots, weight and dynamic driving charges in throats and holes)

Remedial proposal: collect the forces who caused these deformations, recalculation of the component (possibly new profile or striving to strengthen)

Fixes From this assembly has been removed and the rear pipe approach on the torsion built joints.

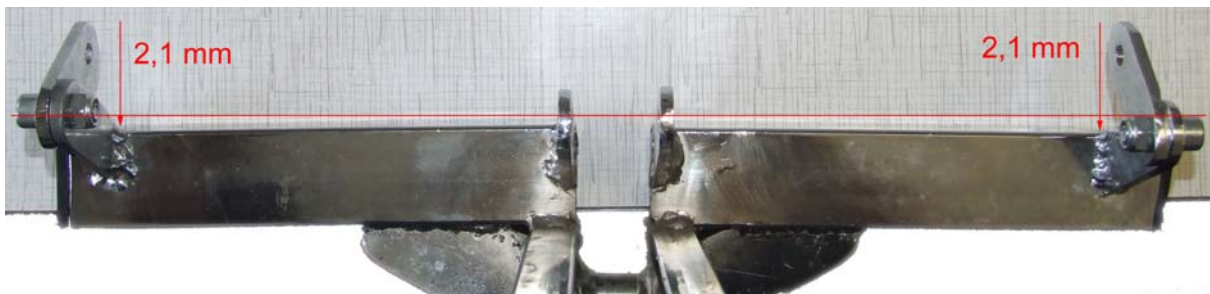
#### 5. Main frame 1 / fixing seat

Damage: squashed

Deviation per page to 2.1 mm (depending on a lever length of 220 mm)

Possible Cause: weight of the driver, excessive leverage, suspension in the middle not used

Fix proposal: here: suspension in the middle use (distance ridges produce)

Later: construct new headquarters suspension (this was a solution for time)

Fixes the seat was also in the middle Screwed

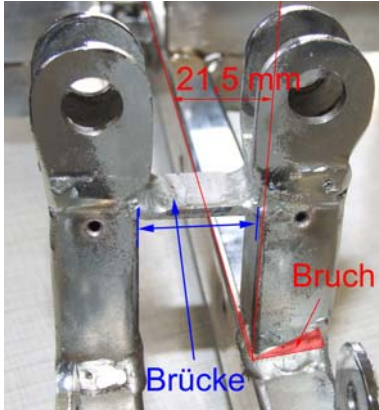
## 6. Main frame 1 / shock absorber bracket

Damage: suspension broke while driving

Deviation: no longer a connection, suspension leaned on the neighbor (21.5 mm)

Possible Cause: lateral shock absorbers burden of progressive leverage

Remedial proposal: Polywrapping a bridge, TIG process (already incurred, blue)

Fix: This assembly was eliminated, and now serves only as a holder of a liaison element of the new spring legs.

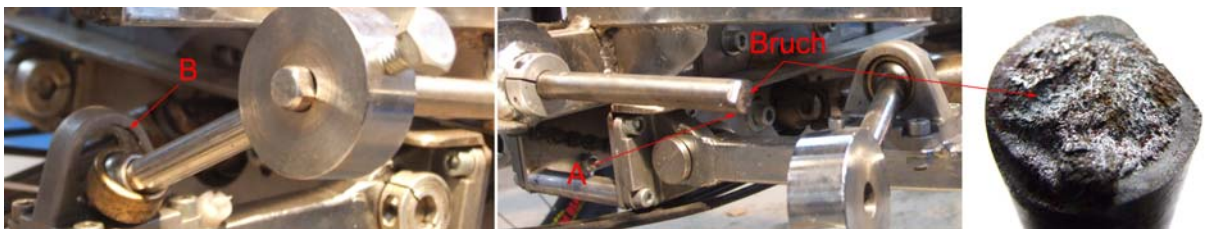
## 7. Cross stabilizer

Damage: A broken right Dorn, torsion fractures

B: joint head left from the bracket glide

Deviations: A: Part destroyed

B: Part destroyed

Possible Cause: A little too much elasticity and torsion forces (too much carbon)

B: agile thorn jammed

Proposed remedy: A: spring steel or other elastic materials (laboratory!)

B: dust caps or other construction (not unparallel!)

Correct: It was spring steel. The mandrels were longer  
Replaced.

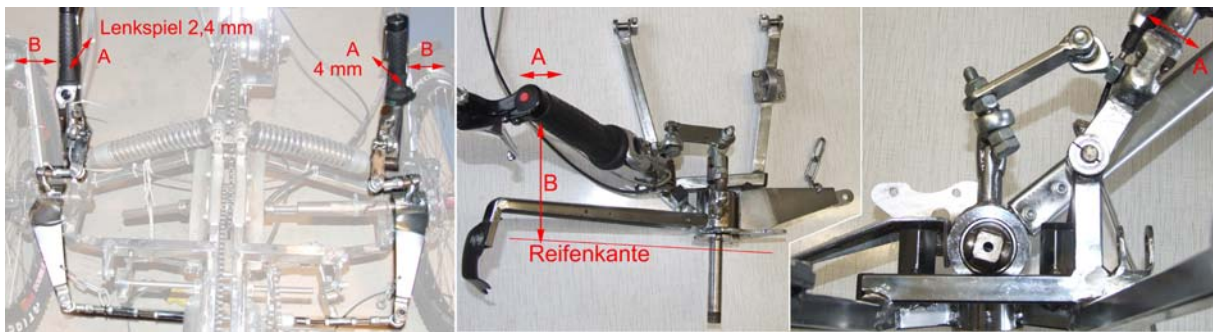
## 8. Steering lever assembly

Damage: no damage to assembly, however:

A: Lack of less instability of the steering transmission, steering game

B: security (driver injured slightly on the wheel)

C: Total construction plump and immature (as adjusted)

Deviations: A: Right: 2.4 mm, links: 4 mm driving game

B: minimum distance between the front wheel steering lever and 7 cm

Possible Cause: A lack of precision, too much leverage and joints in flux

B: an almost constructed

C: lack of time during the construction (16 h of the idea to

Fix proposal: re-do the AC construction on the paper

Fixes have been given new joint heads and stronger materials

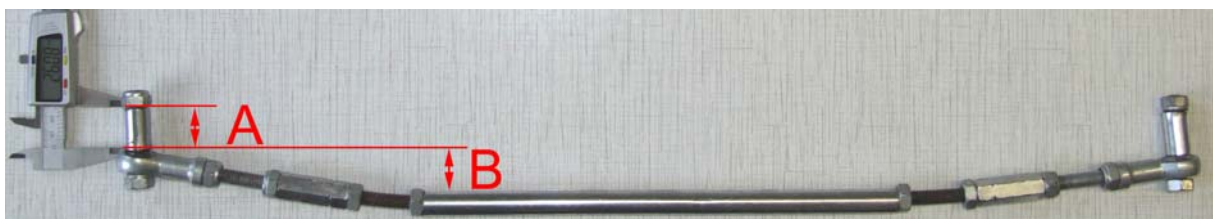
## 9. Track rod

Damage: bent

Deviations: A piece distance of 26 mm length had after first race

B: bilateral crank by 27 mm to leverage length of 180 mm

Possible Cause: Deflection of the front axle, while immersing was part of the axis in the way

Fix proposal: 1: driving deeper build leg (saving the distance)

2: crank, track rod build stable, perhaps from composite

3: Total construction, or otherwise completely rethink

Fixes By using a new chassis, could also be deep immersion of the vehicle frame prevented.

The track rod was treated and again with new joint heads. It is now just built and is not in conflict with other components. A component change was not necessary.

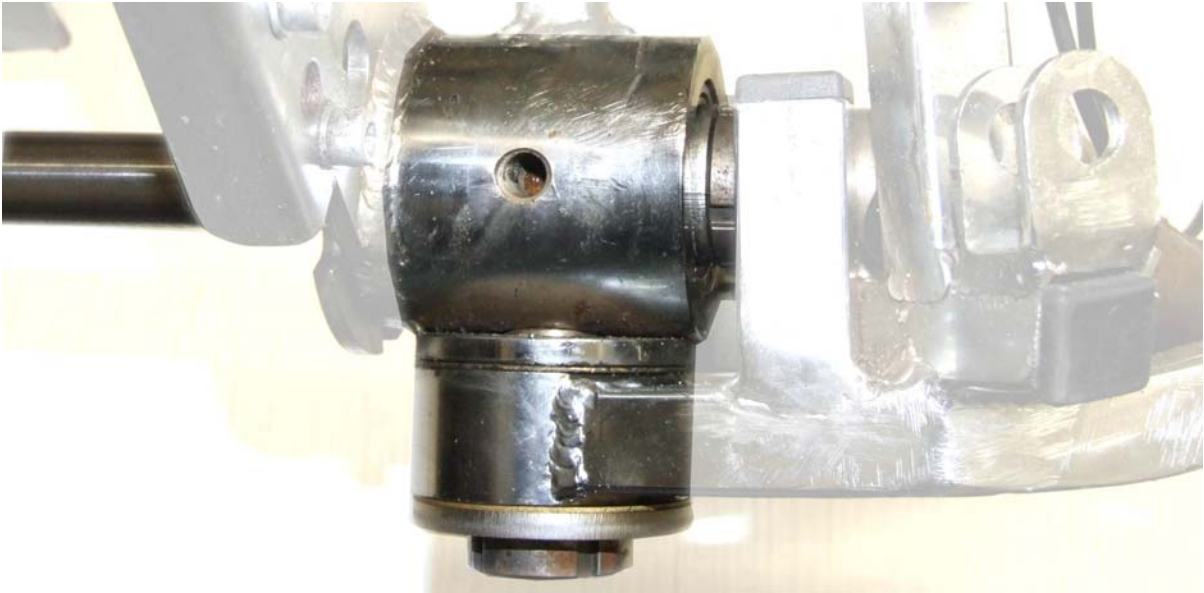
10. Suspension assembly and storage front

Damage: no visible external damage, but too heavy

Possible reason: to find the complicated design, oversized  
Fix proposal: less material, lighter materials / other construction

Solution: No special modifications.

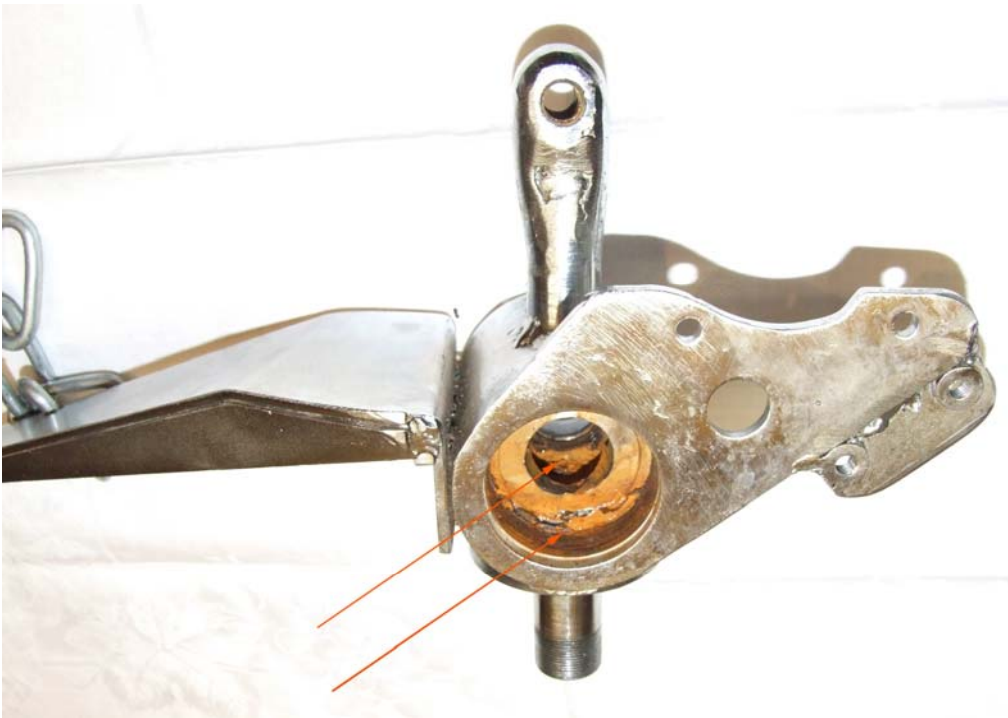
Damage: strong rust appearances inside the warehouse keeper and the parts

Possible Cause: not-sealed borehole, no fat, condensation and Splash residues could not dry

Remedial proposal: seal holes; spaces fill with fat

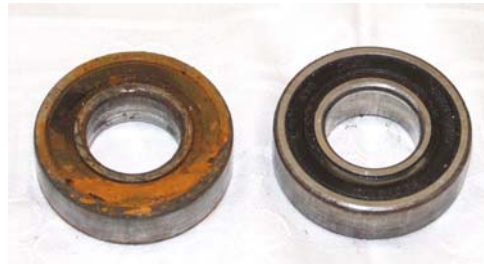
Rust also on the ball bearings on the inner side (left),  
Outside is not (right)

Damage: Ball bearings are hard to dismantle

Possible Cause: too small a hole between the ball bearings  
Proposed remedy: wider hole

Fix: No changes, new ball bearings used

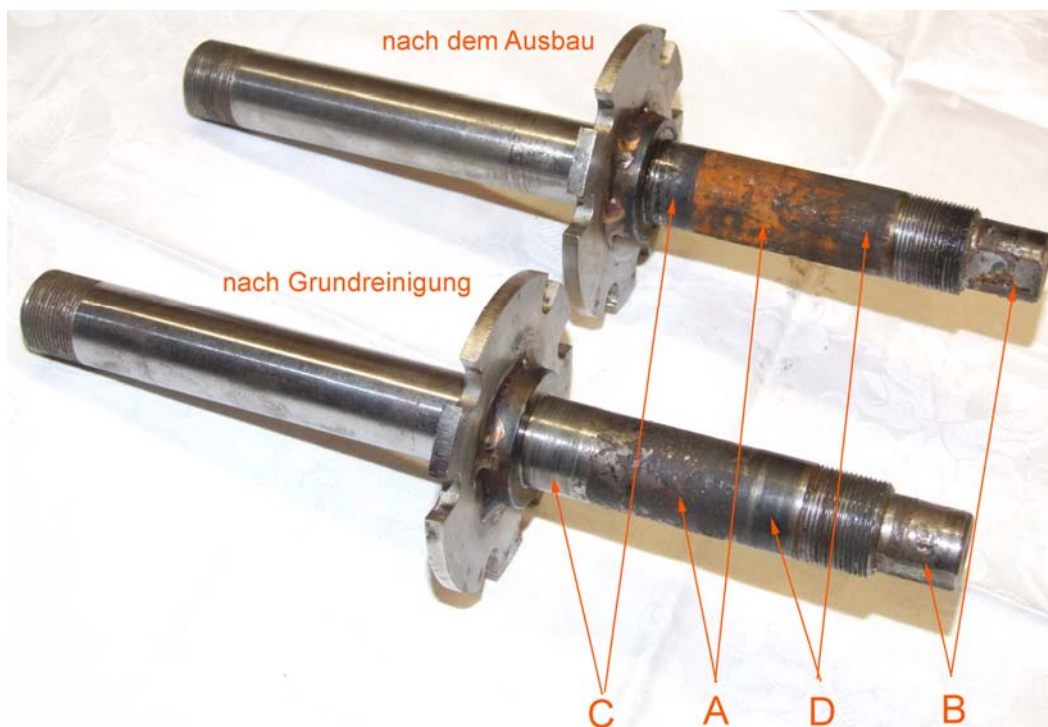
Damage Pictures: A strong rust appearances between the camps  
 B: the corrosion of that axle to cross joints  
 C: scratch at the camp headquarters  
 D: Corrosion image at the camp headquarters

loupe crosses joint connection (the corrosion of that axle)

Possible Cause: A: Not sealed hole  
 B: Not yet sophisticated power transmission  
 C: ball bearings are too tight, turned on the shaft  
 D: water could corrode ball bearing seat

Proposed remedy: A + D: seal holes, bearings with grease  
 B: other construction (e.g. hexagonal)  
 C: the installation of the ball bearing to ease the eighth

Fixes holes filled with grease, thread instead of using hexagonal

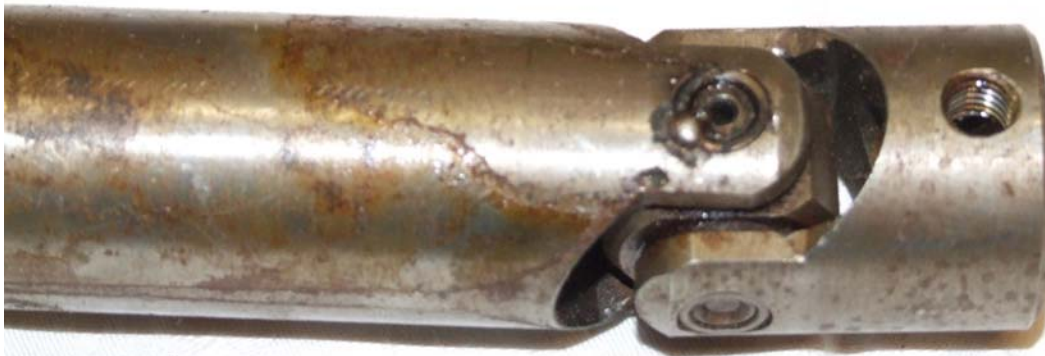
Damage Image: Cross joints broken  
 Possible Cause: missing differential gear overload  
 Remedial suggestion: use differential gear

Fixes assembly completely new designs  
 Cross-smaller joints used  
 Wave from several parts  
 Thread as a port (right / left)

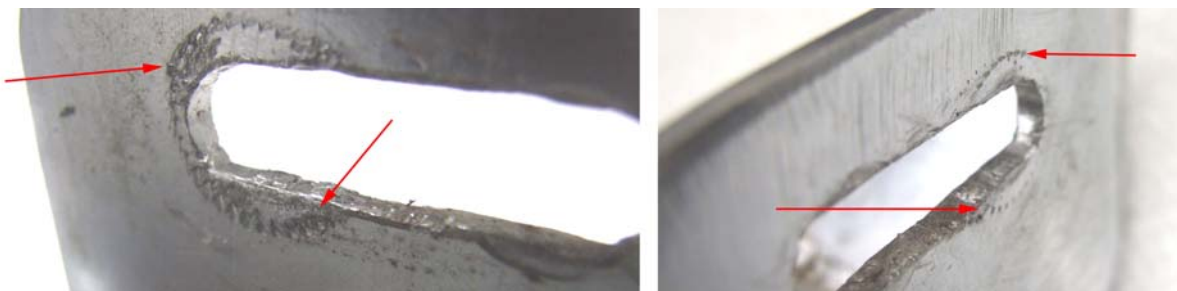
## 12. Gear brackets

Damage pattern: Bruising of long hole for gear axle holder, surface damaged,

Deviation: up to 0,5 mm

Possible cause: Base of the gear slipped into the brackets, excessive force despite form closure and high torque of fine threaded nuts

Repair proposal: Construct spanner to lock in either direction (similar to chain)

Repair: construct new brackets for Rohloff gear

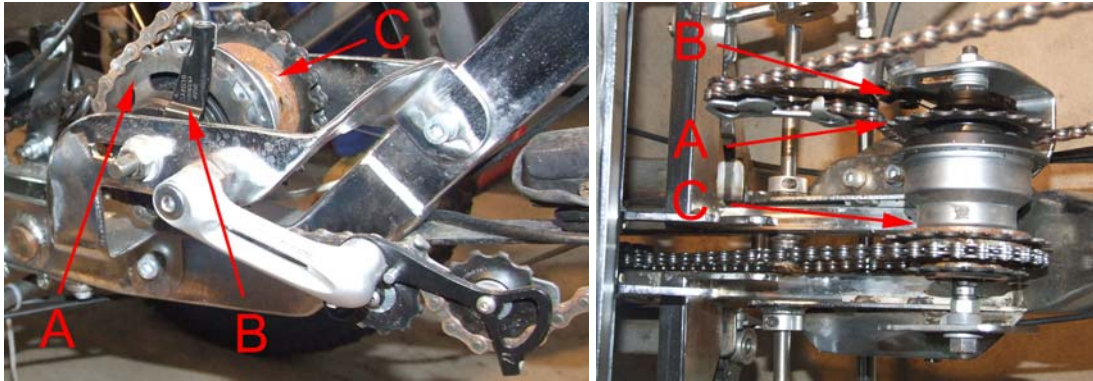
### 13. Hub gear

Damage pattern: A: Drive pinion broke several times during test drives  
B: Total loss during the 2nd Race (front gear)  
C: rusty spacer ring

Deviation: A-B lead to complete loss of the assemblies

Possible cause: A: Form closure with spring too small  
B: consequential damage to gear after failure of the transmission chain in the front  
C: missing corrosion protection

Repair proposal: A: fixated with welding points – in fact a different gear is required  
B: save chain gear– needs another hub gear  
C: Paint, Color coat

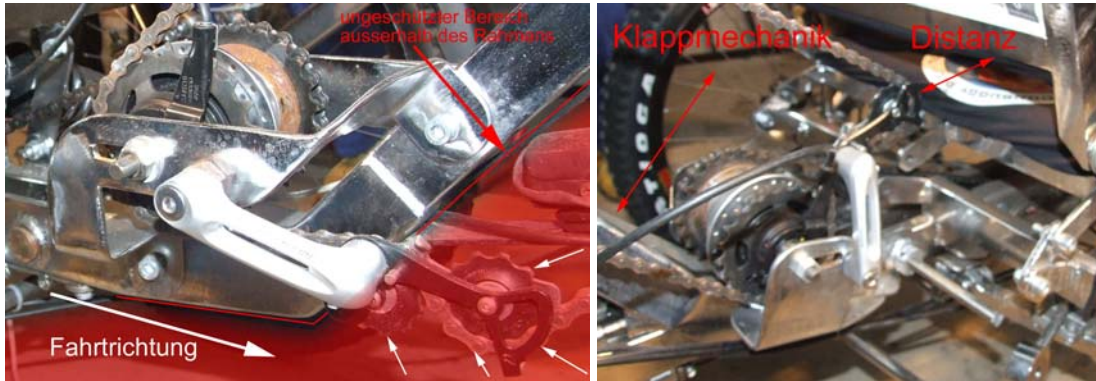
## 14. Chain gear

Damage pattern: A: in front: gear completely destroyed  
B: at the back: chain pops out of the pinion  
Deviation: A-B lead to complete loss of the assemblies

Possible cause: A: Chain lies in the unprotected area outside (left)  
B: Chain stretcher collides with the seat (right) when collapsed due to very small distance  
Repair proposal: A: save chain gear– needs another hub gear  
B: save chain gear– needs another hub gear  
Repair: Assembly removed and replaced with Schlumpf-gearbox
