Subject: ISS On-Orbit Status 08/12/05

## FOR OFFICIAL USE ONLY ISS On-Orbit Status 08/12/05

## STATUS REPORT Date Released: Thursday, October 20, 2005

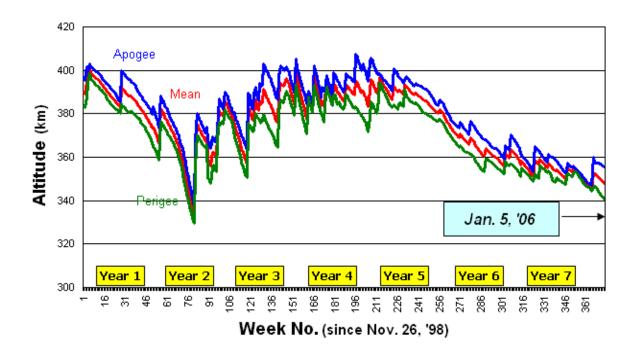
## **ISS Altitude History**

Apogee height -- Mean Altitude -- Perigee height
