## **Most Improved Award**

**German Space Education Institute  
Moonbuggy Team 2008**

## **1. Damage – analyses - causation – adjustment**

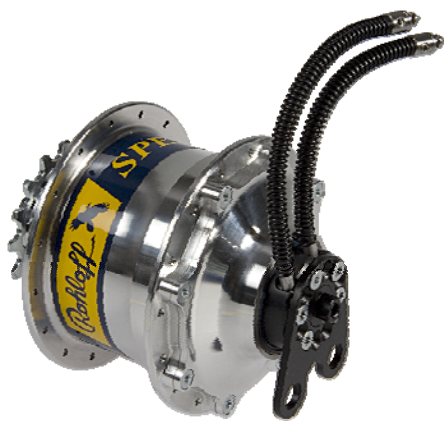
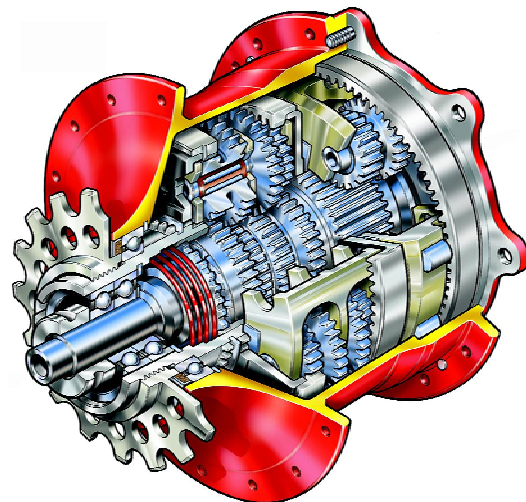
New Gear box: 14-gear Speed hub from Rohloff

Damage pattern: A: Drive pinion broke several times during test drives  
B: Total loss during the 2nd Race (front gear)  
C: rusty spacer ring

Possible cause: A: Form closure with spring too small  
B: consequential damage to gear after failure of the transmission chain in the front  
C: missing corrosion protection

Repair proposal: A: fixated with welding points – in fact a different gear is required  
B: save chain gear– needs another hub gear  
C: Paint, Color coat

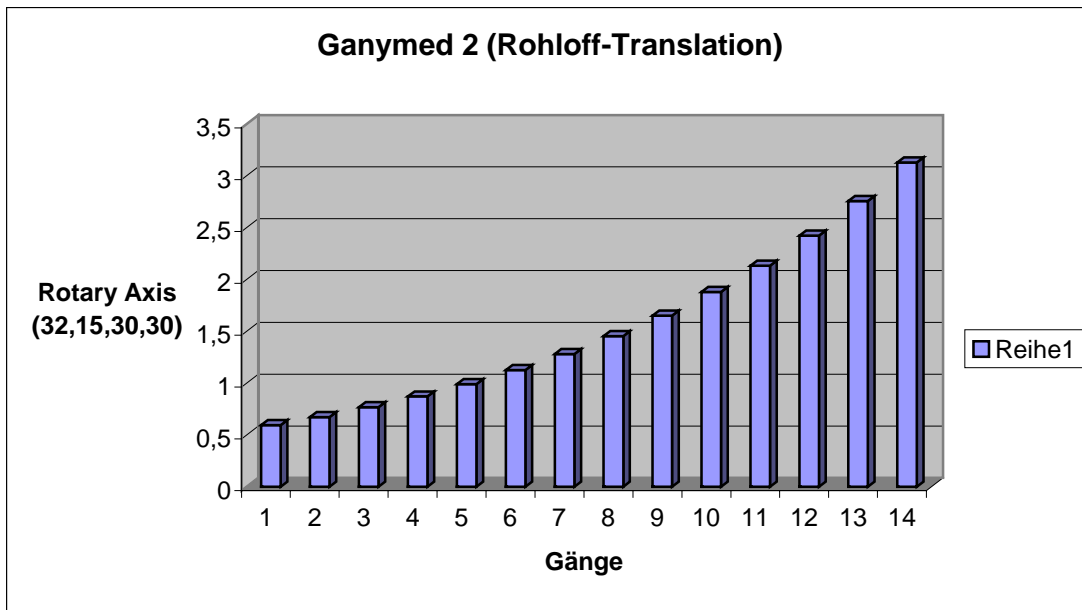
Gearbox table new

It is visible that the choice of the gear is now clearly arranged. This saves time.

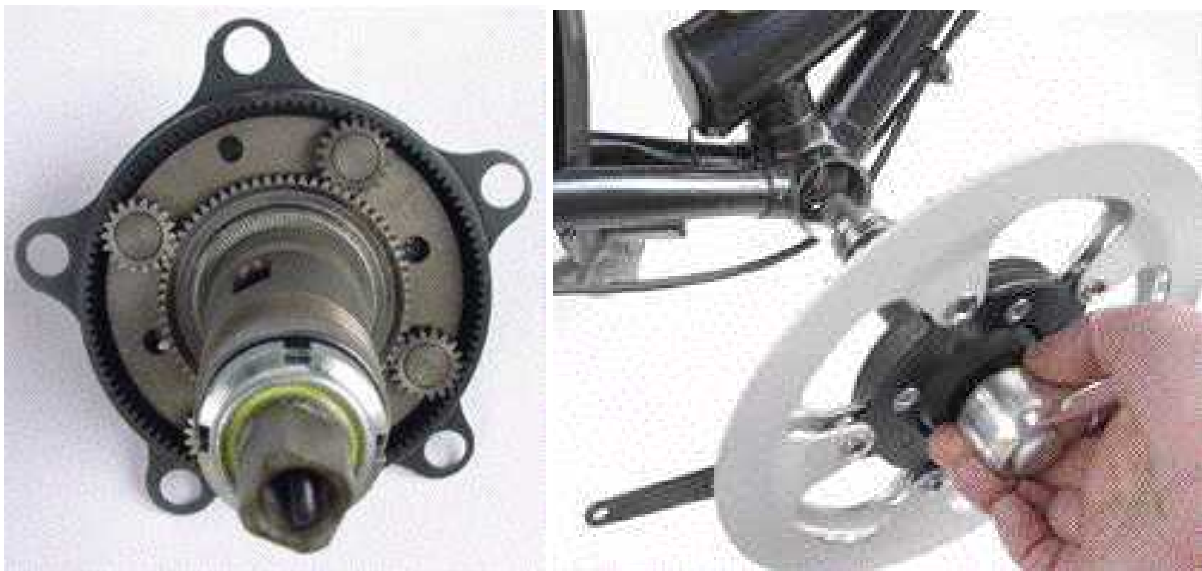
Damage pattern: A: in front: gear completely destroyed  
B: at the back: chain pops out of the pinion  
Deviation: A-B lead to complete loss of the assemblies

Possible cause: A: Chain lies in the unprotected area outside (left)  
B: Chain stretcher collides with the seat (right) when collapsed due to very small distance  
Repair proposal: A: save chain gear– needs another hub gear  
B: save chain gear– needs another hub gear  
Repair: Assembly removed and replaced with Schlumpf-gearbox

Schlumpf Innovations GmbH (Switzerland) offers very interesting planetary gearboxes. This is part of the bottom brackets and can be switched in 2 gears. While a gear always gives a 1:1 ratio, the intermediary planetary gear provides following outputs: 1: 2.5, 1: 1.65, 1: 0.4.

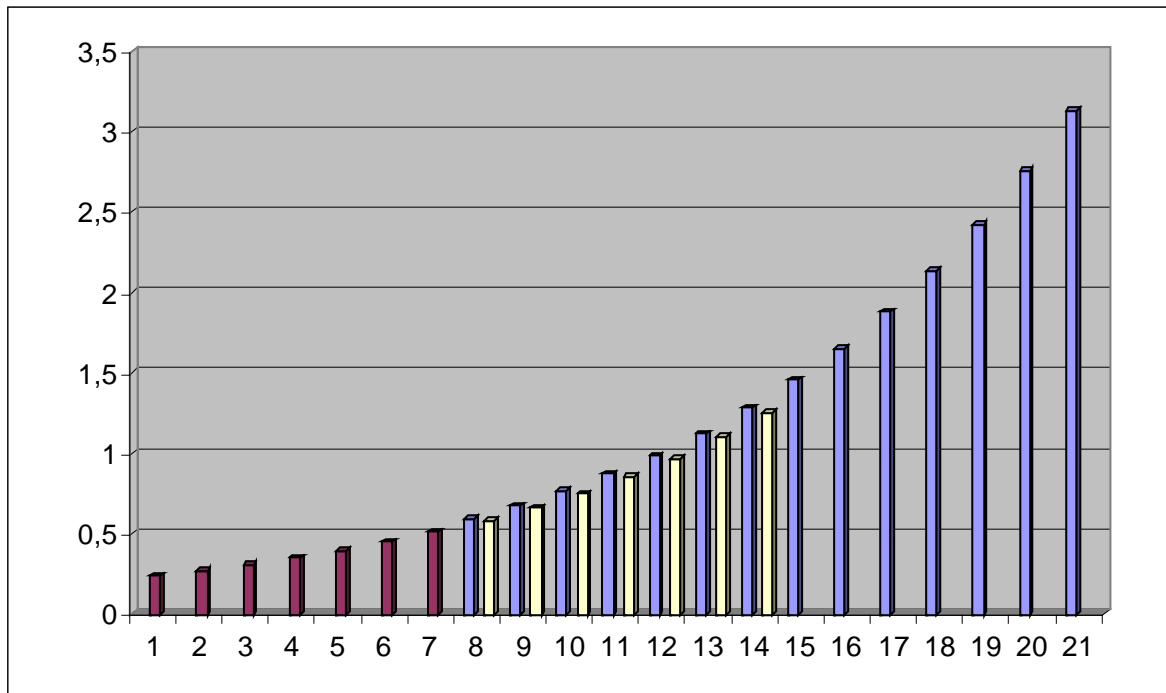
Speed behavior of Ganymed 1B with double Schlumpf- + 14-times Rohloff-Switch,  
(Rohloff-gears in blue, in red are low-speed-gear reductions with help of Schlumpf-planetary  
gear brackets, overlapping gears in yellow, Total: 21 real gears)  
Engine speed volume: from 0.23 to 3.12
